DELAWARE STATE HISTORIC PRESERVATION OFFICE

7	8	. \		15	THE GREEN,	DOVER, DE 19901
		CULTURAL RESO	LIRCE SURVEY		CRS#	K-7375
	\mathbf{m}	PROPERTY IDENT			SPO Map	
A		I KOLEKII IDENI	II ICATION FOR	KIAI	or o map	South
					Hundred	Murderkill
						Frederica
					Quad	riederica
					Other

1.	HIST	ORIC NAME/FUNCTION:	L. Webb/Residence	е		
2.	ADDI	RESS/LOCATION: West S	Side of SR 1; 6947 E	Bay Road		
3.	TOW	N/NEAREST TOWN: Fred	erica			vicinity?

4.	MAIN	TYPE OF RESOURCE:	building 🛭 landscape 🗌	structure district	□ site	object
5.	MAIN	FUNCTION OF PROPERTY	: Residence			
6.	PRO	JECT TITLE/ REASON FOR	SURVEY (if applica	able):		
		Little Heaven Interchange

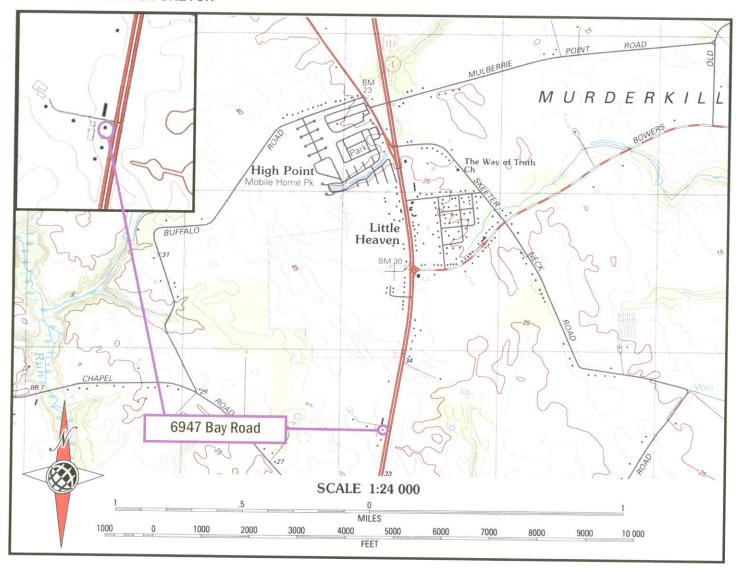
1.	ADDRESS/LOCATION: 6947 Bay Road, South Murderkill Hundred, Kent County
2.	NOT FOR PUBLICATION reason:
3.	LOCATION MAP:
	Indicate position of resource in relation to geographical landmarks such as streams and crossroads.

(attach section of USGS quad map with location marked or draw location map)

INDICATE NORTH ON SKETCH
